# Manhole Inspection Summary

Manhole # **S35C\_\_071MH**

Insp Date: **8/10/09 6:57 PM**

**Location** Address: **112 N. Calvert St**

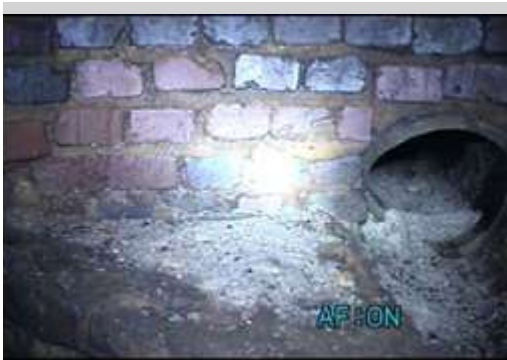
Miscellaneous

debris on bench

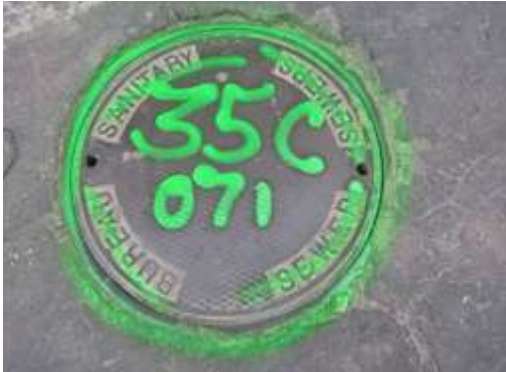
Miscellaneous

Condition: **Worn**

worn mh cover

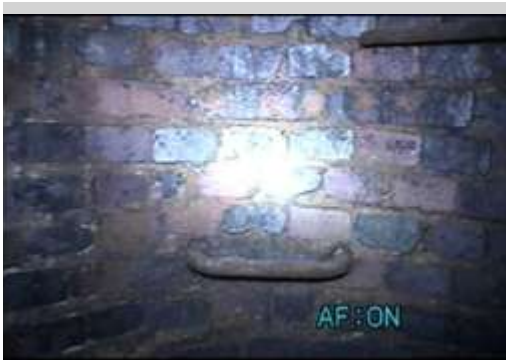
Defect 2

Count: **10** Missing: **0** ☒ **Corroded**

corroded rung

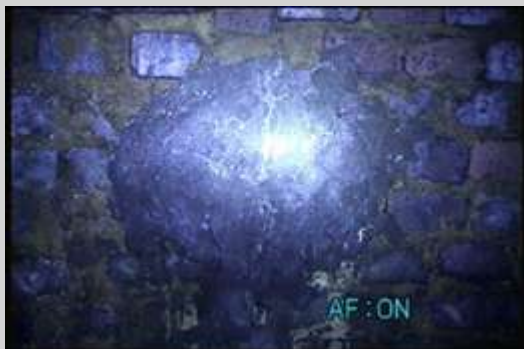
Drop In @ 6 OClock

I6 drop...abandoned

Connects To: **Stub connection / abandoned**

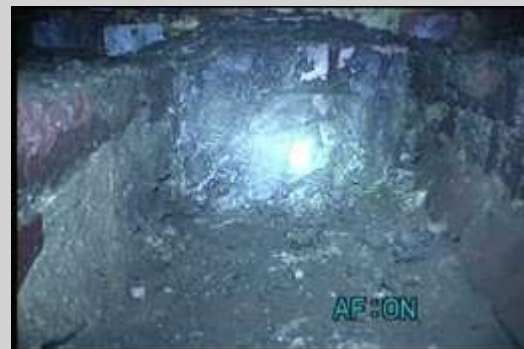
I6 drop extension...abandoned

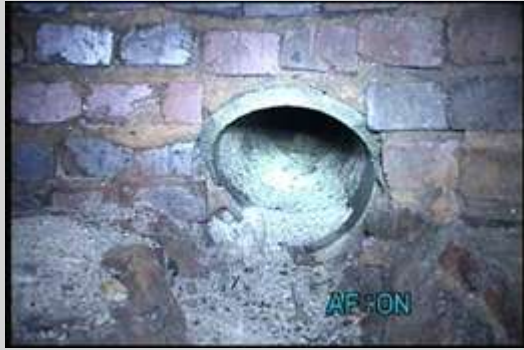
8 O'Clock Inflow

debris in channel
